Figure 1: Sample front-projected SEOS PRODAS display for a Sports Utility Vehicle

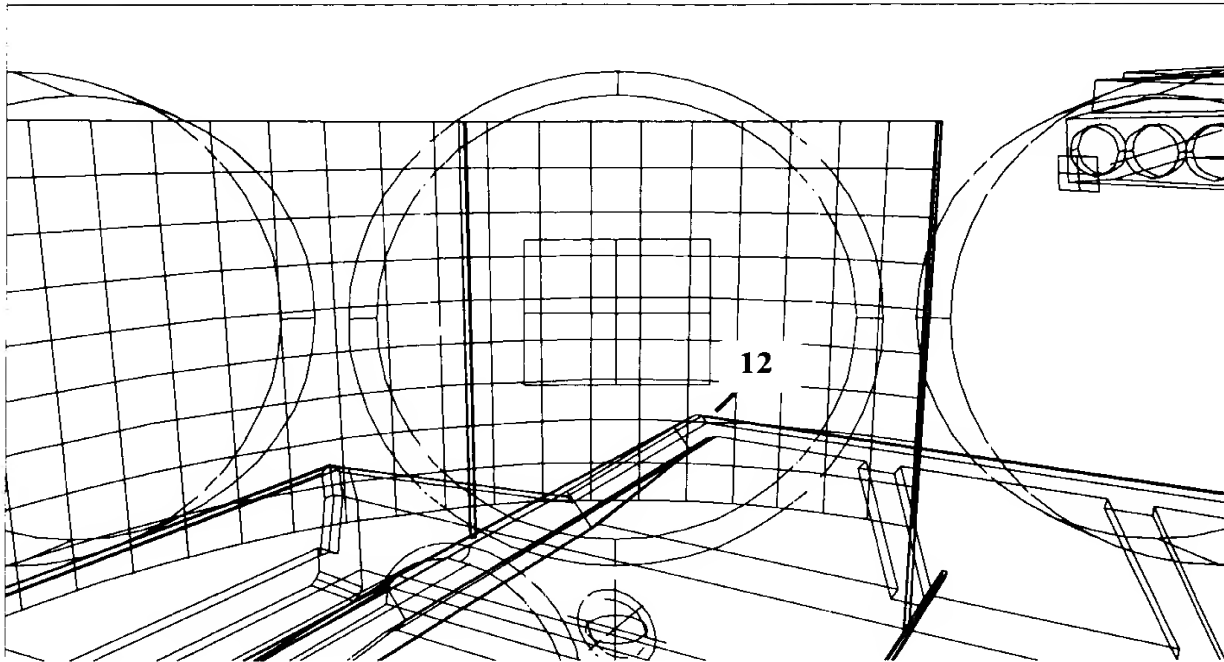
Figure 2: Field of view occlusion from vehicle cab.

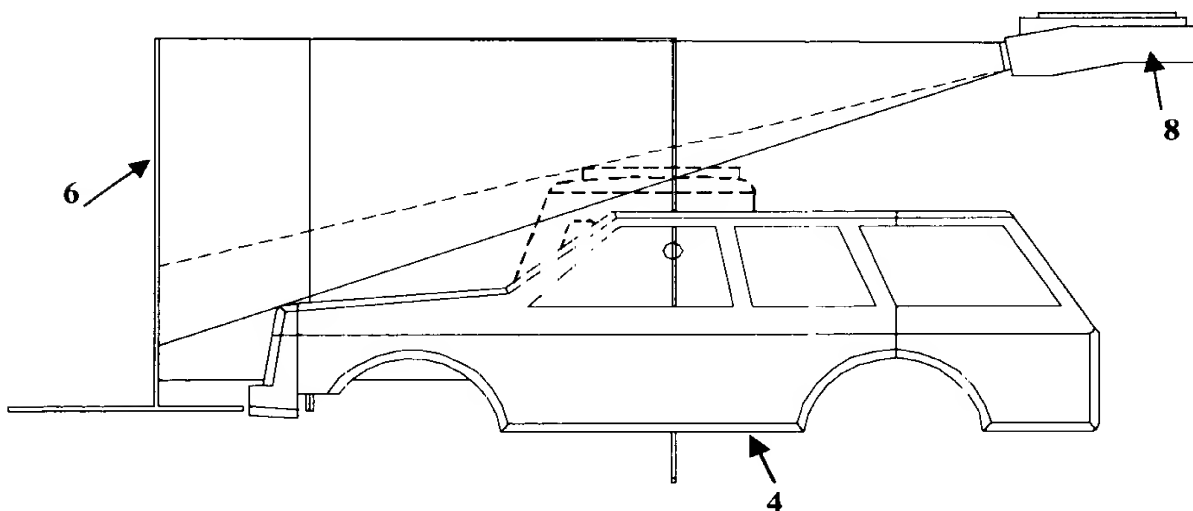
Figure 3: Dotted lines indicate extents of truck - More shadowing !!!!

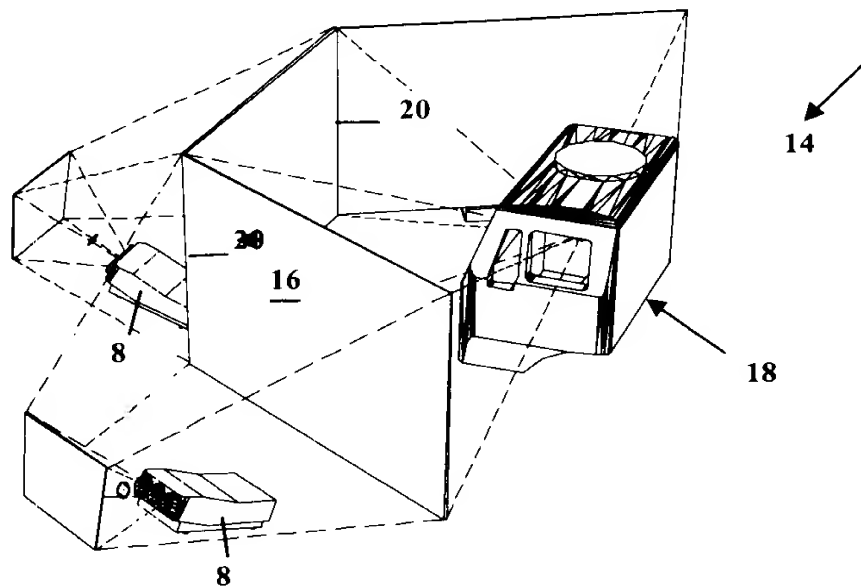
Figure 4: Rear-projected display for a truck simulator.

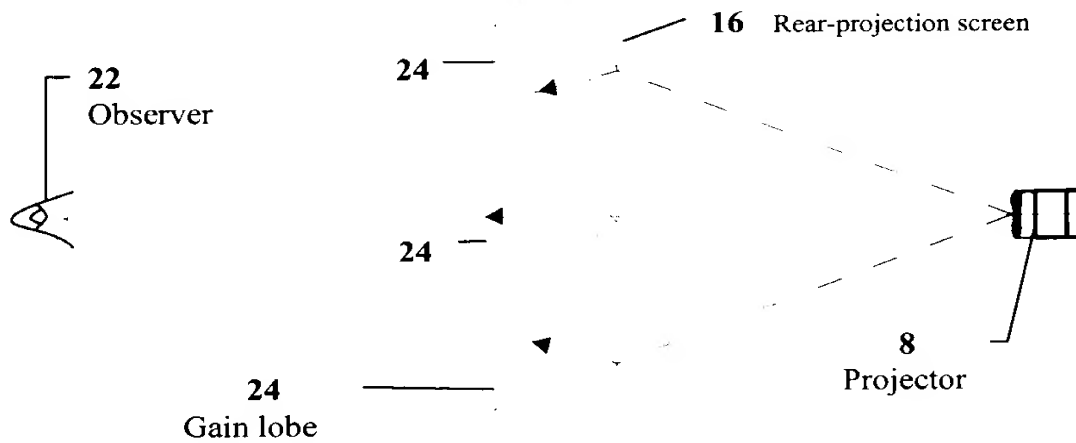
Figure 5: Rear-projection screen gain effect.

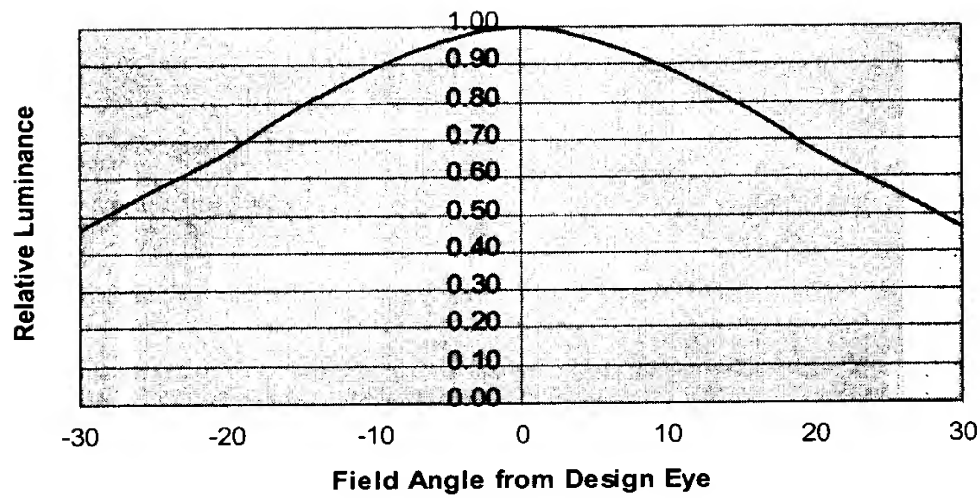
Figure 6: Luminance uniformity of rear-projected image

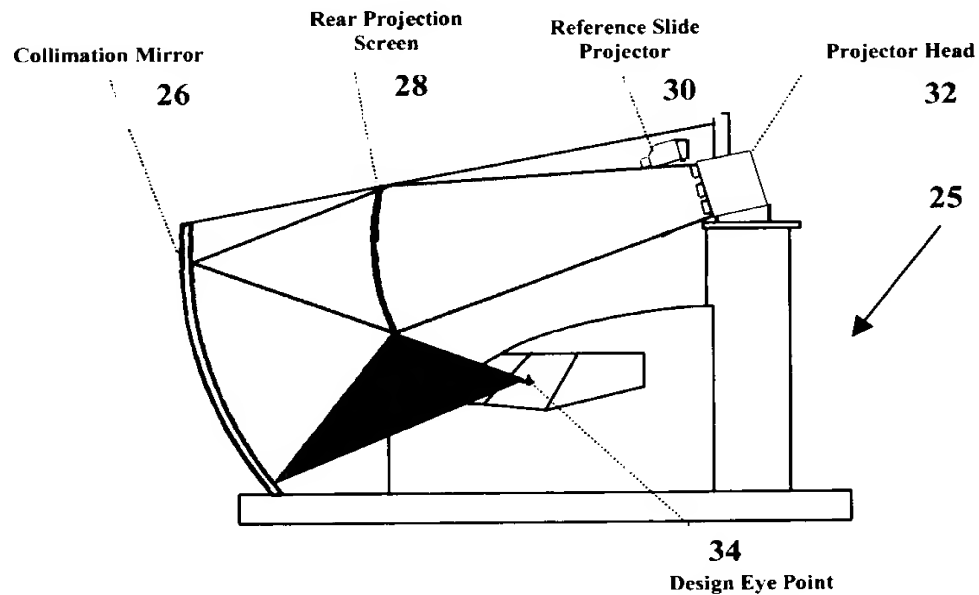
Figure 7: Tilted Mirror Collimation Flight Simulator Display

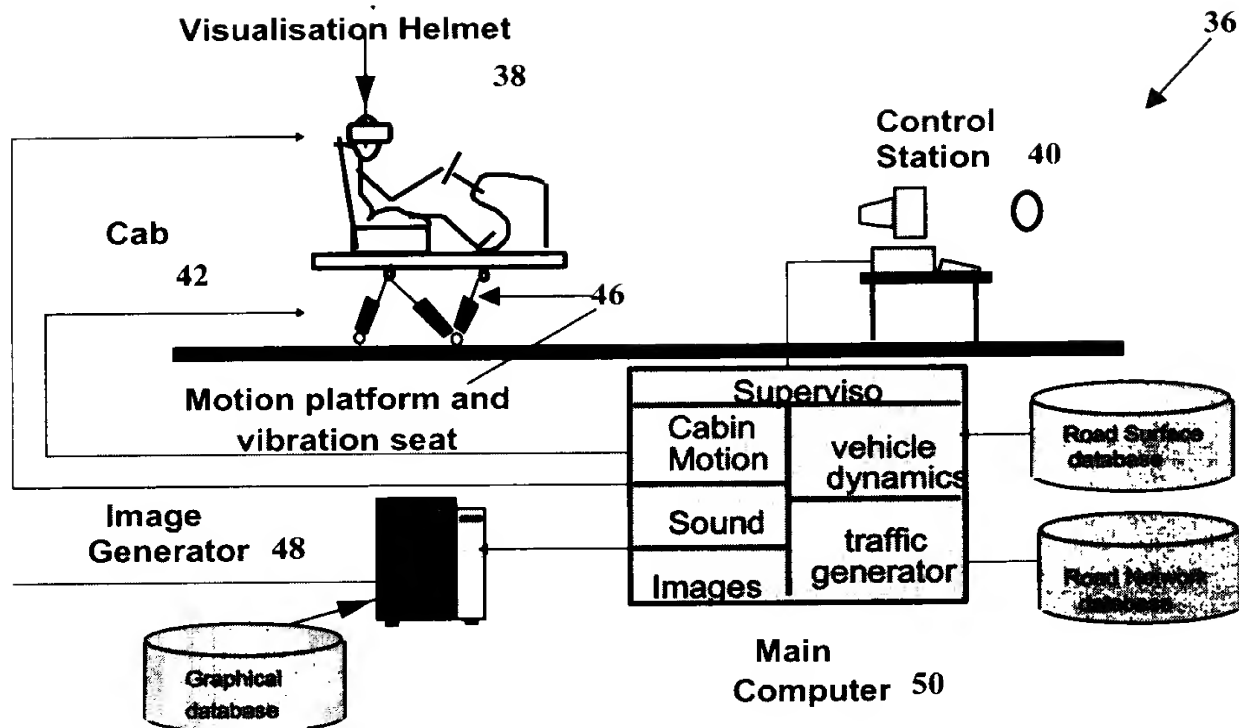
Figure 8: Comprehensive Automobile Research and Development Simulator system

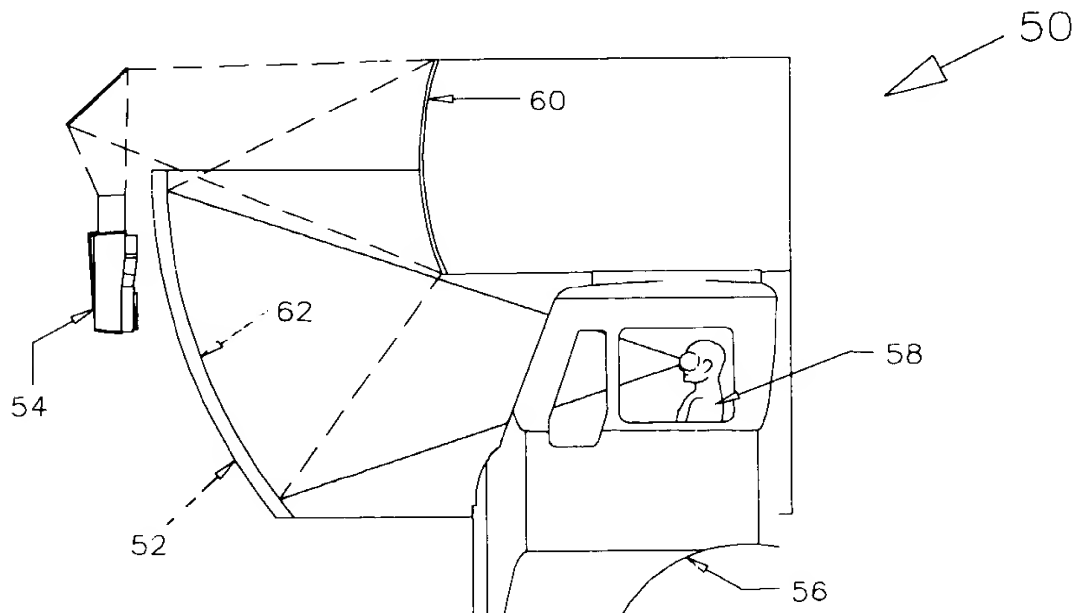
Figure 9: Front-projected PANORAMA side view

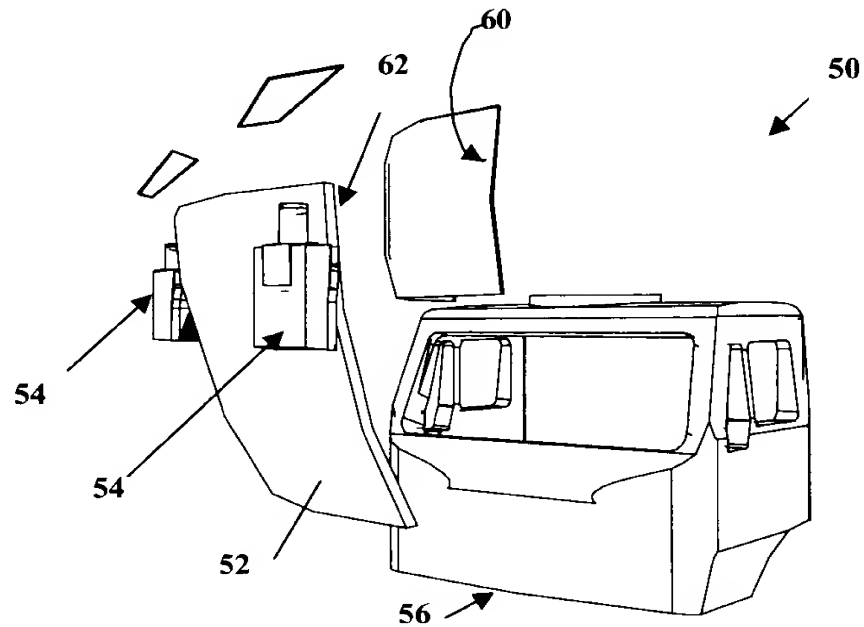
Figure 10: Cut-Away Perspective

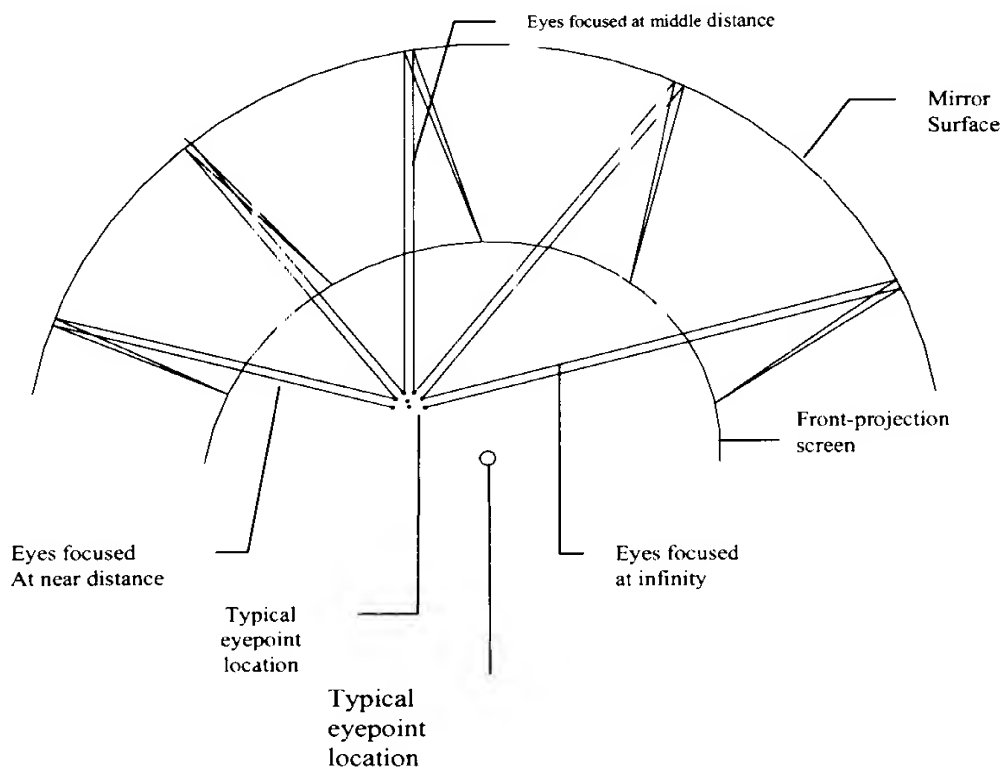
Figure 11: Plan view of collimation system showing image distance reduced to the driver's side and increasing distance towards the opposite side of the field

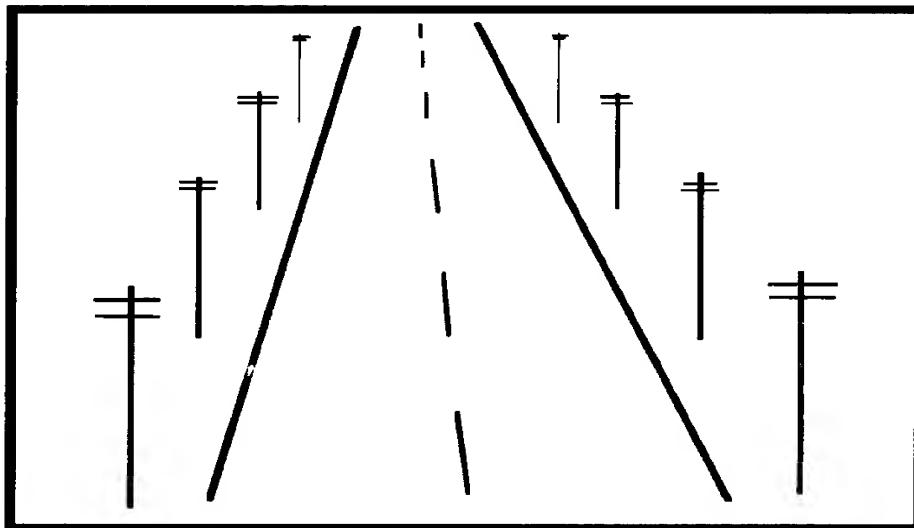
Figure 13: Pre-distorted Image

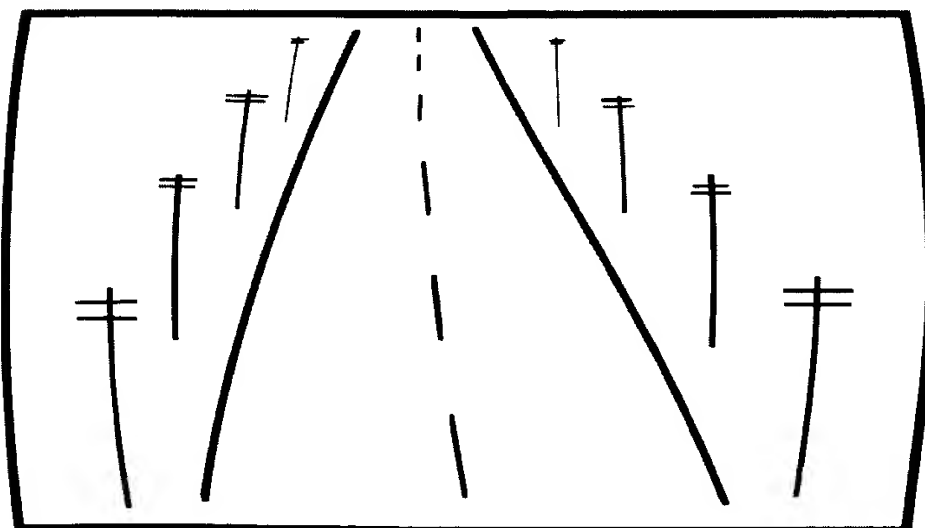
Figure 14: Distorted Image
